Inspection Report

Property Address:
123 Sample Street
San Francisco CA 94123

This is a Balcony and Deck Inspection Report and cites the conditions of the balcony and deck systems as it relates to the Balcony Inspection Law (Senate Bill #721 (Chapter 445)).

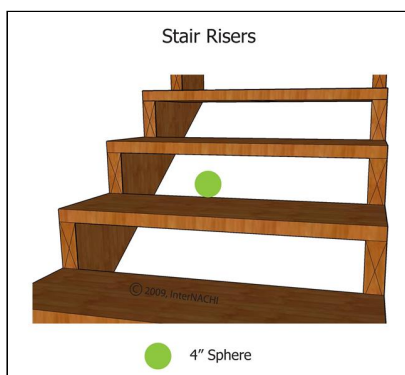
1.0 Item 1(Picture)

Safety Recommendation: The step risers to the back deck were open and larger than 4" inches. This is a safety hazard for small children who may be able to crawl through the open riser and fall. Current safety standards do not allow for risers with openings larger than 4". For optimum safety, we recommend making these upgrades to conform to modern safety standards.

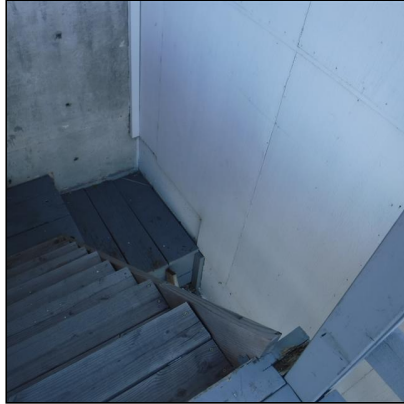
1.2 Item 1(Picture)

The back deck stairs did not have a handrail. This is consider a life safety hazard and requires immediate repair. Recommend blocking these steps off from occupant access until a handrail can be installed and inspected.

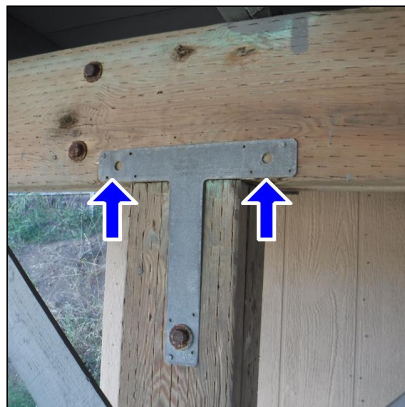
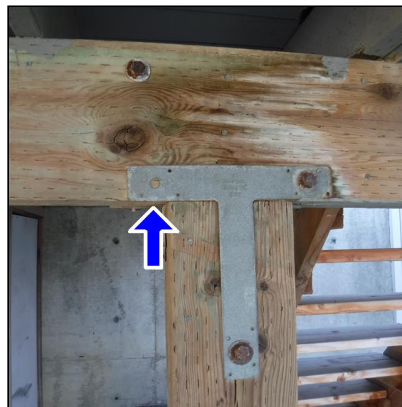
Multiple beam to post connectors were missing fasteners. Recommend this be corrected.

Multiple beam to post connector bolt holes were too close to the lower beam edge. Current standards require at least 2-1/2" from bolt end to edge of lumber. Recommend this be corrected.

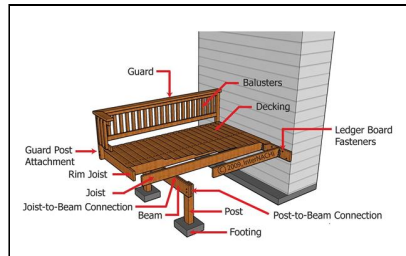
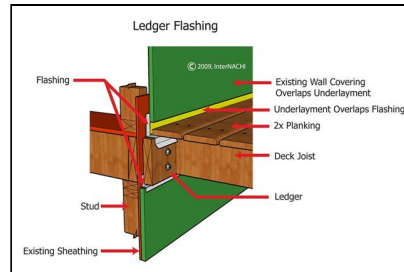
No ledger flashing or waterproofing was visible during the inspection. The CA balcony Law requires the confirmation of flashing or waterproofing system has been installed. This system is critical to the deck structure and its safety. Recommend this be immediately corrected and blocking access to the deck structure until this condition has been repaired and inspected. The condition of the ledger board and its connectors should be inspected and confirmed after proper access has been given and before the installation of a flashing or waterproofing system are properly installed.

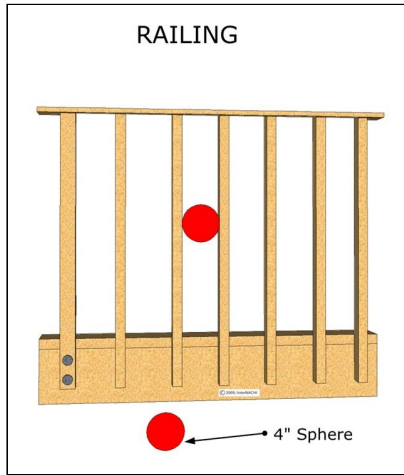
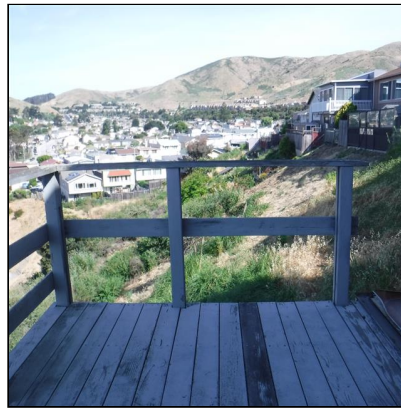
(1) The balusters at the back of the building were larger than 4" apart and too large according to modern safety standards. For optimal safety, we recommended that a new baluster system be installed with gaps less than 4" inches.

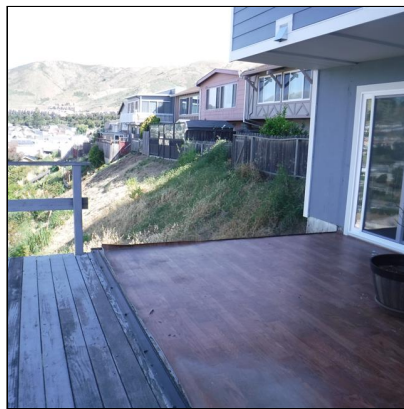
6.0 Item 3(Picture)

(2) The guardrail was missing in multiple locations on the back deck. This is a life safety hazard. Recommend blocking off access to the deck from occupants and have a deck guardrail installed and inspected.

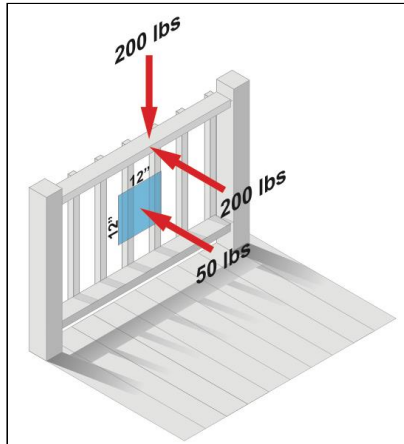
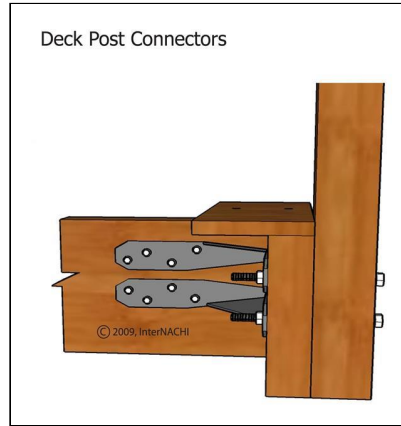
The guardrail around the back deck is loose and not properly secured in one or more locations. Modern standards require guardrails to be able to withstand a concentrated load of 200 lbs. per square foot in any direction. Recommend the guardrail be repaired by a qualified licensed contractor.
