Inspection Report

Property Address:
XXXX Stonebridge Drive
Livermore CA XXXXX

PCA Home Inspections

Date: 2/3/2017	Time: 10:00 AM	Report ID: 137004
Property: XXXX Stonebridge Drive Livermore CA XXXXX	Customer: Shelly Chaudhuri	Real Estate Professional:

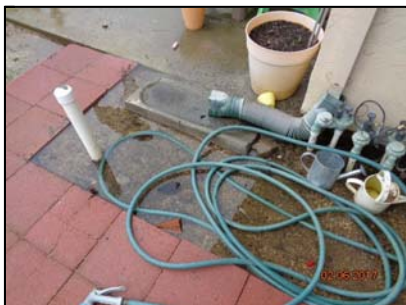
1.0 Item 1(Picture)

1.0 There is poor drainage in some areas around the perimeter of the foundation, mainly in the back corner of the building Item 1(Picture). This should be corrected to help minimize future foundation problems. This is a maintenance item.

There is poor drainage in some areas around the perimeter of the foundation, mainly in the back corner of the building Item 1(Picture). This should be corrected to help minimize future foundation problems. This is a maintenance item.

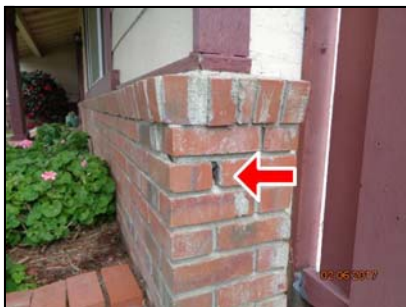
1.1 Item 1(Picture)

1.1 Some slight cracking was noted in the brick cladding at the front right of the building.

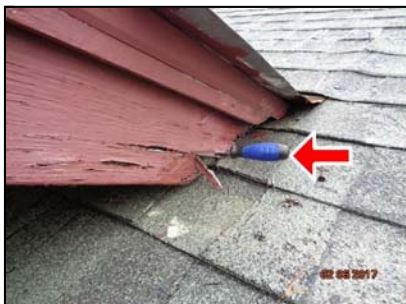
1.2 Item 1(Picture) Roof Rack Dry Rot

1.2 Some dry rot was found on the garage roof rack. Item 1(Picture)

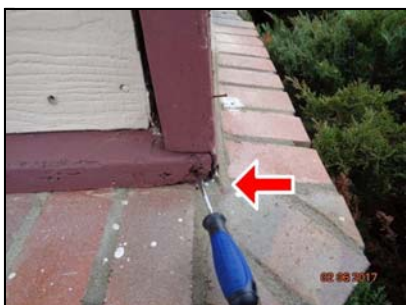
1.3 Item 1(Picture) Trim Next to Garge

1.3 Some dry rot was evident in front trim next to the garage. Recommend repair and sealing any damage or exposed wood to prevent further damage.

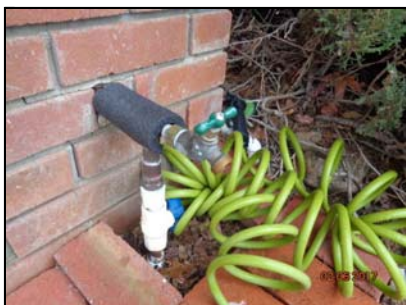
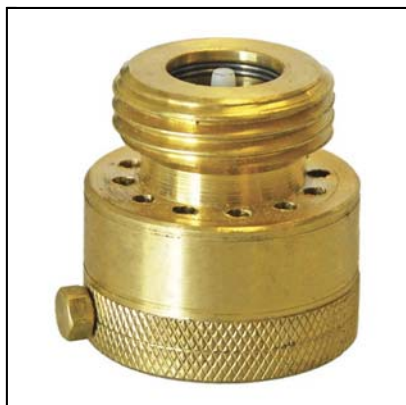
1.4 Item 1(Picture)

1.4 Recommend anti-siphon devices be installed on the exterior water faucets.

Recommend anti-siphon devices be installed on the exterior water faucets.

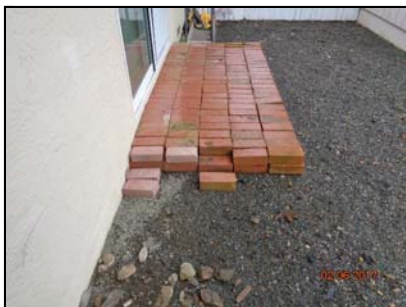
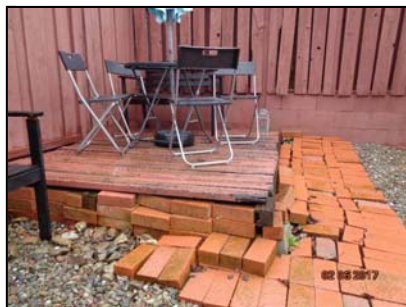
1.6 Item 1(Picture)

1.6 Loose brick walkway and porches at the back of the building are unsafe and a tripping hazard.

Loose brick walkway and porches at the back of the building are unsafe and a tripping hazard.

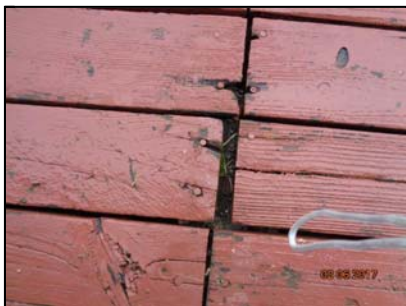
1.7 Item 1(Picture)

1.7 The deck in the back of the main building has some loose boards and large gaps.

The deck in the back of the main building has some loose boards and large gaps.

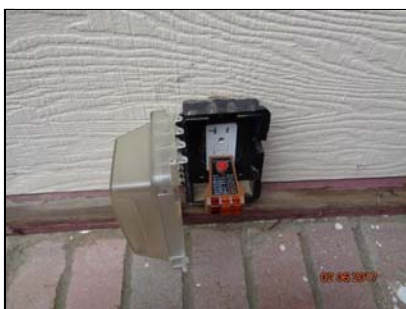
1.9 Item 1(Picture)

1.9 (1) The electrical outlet(s) in the front next to the garage register no electricity.

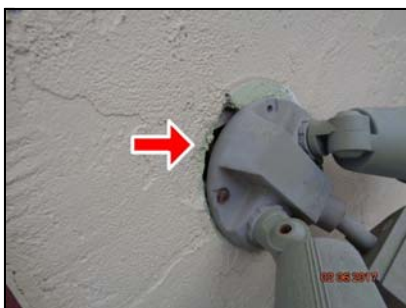
1.9 Item 2(Picture)

1.9 (2) A gap was noted between the light fixture and the stucco next to the garage.

(2) A gap was noted between the light fixture and the stucco next to the garage.

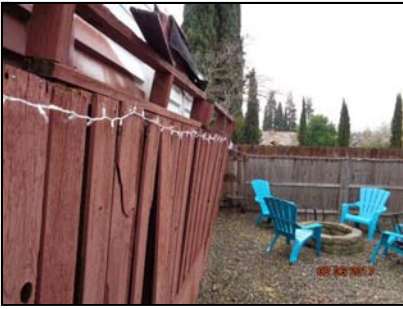
1.10 Item 1(Picture)

1.10 The fence at the rear of the property is not properly secured.

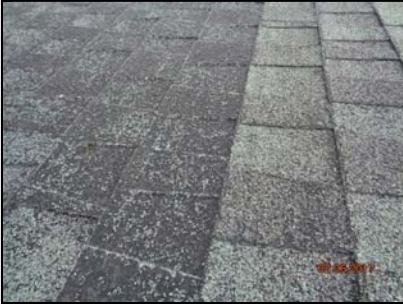
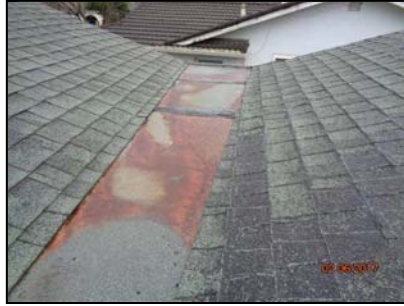
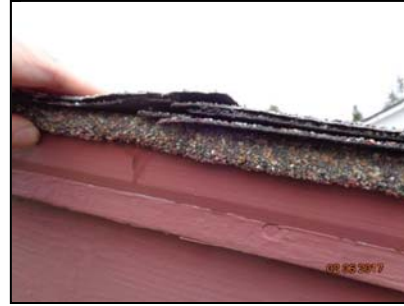
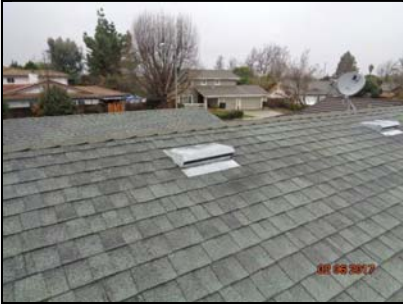
2.0 Item 1(Picture)

2.0 (1) The roof on the main building appears to be beyond its intended life span. Granulation and curling of the shingles was noted. However, there are no indications of water penetration at this time. Recommend further evaluation of a licensed roof contractor.

- (1) The roof on the main building appears to be beyond its intended life span. Granulation and curling of the shingles was noted. However, there are no indications of water penetration at this time. Recommend further evaluation of a licensed roof contractor.
- (2) There are several exposed nails. With time, exposed nails will rust, loosen, and may cause leakage. We recommend the exposed nails be sealed, removed, covered, or otherwise properly repaired by a qualified roofer.
- (3) A missing shingle was noted on the roof of the rear building. It is recommended that the missing shingle be replaced when roof work is performed.

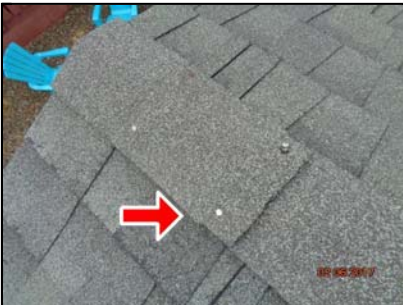
2.0 Item 5(Picture)

2.0 (2) There are several exposed nails. With time, exposed nails will rust, loosen, and may cause leakage. We recommend the exposed nails be sealed, removed, covered, or otherwise properly repaired by a qualified roofer.

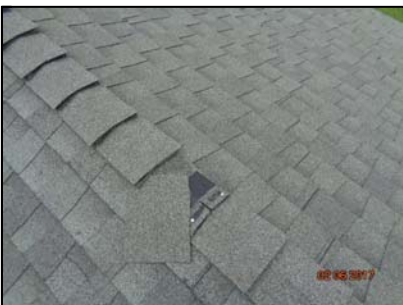
2.0 Item 6(Picture)

2.0 (3) A missing shingle was noted on the roof of the rear building. It is recommended that the missing shingle be replaced when roof work is performed.

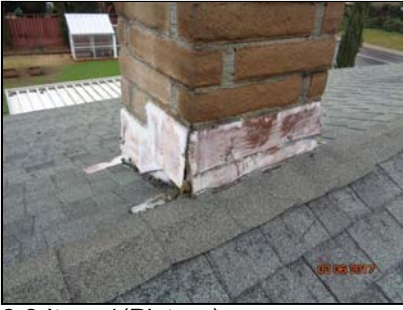
2.2 Item 1(Picture)

2.2 (1) The flashing around the chimney appears to have been repaired using a sealant. Sealant tends to deteriorate over time. Recommend this be further evaluated by a qualified roofer.

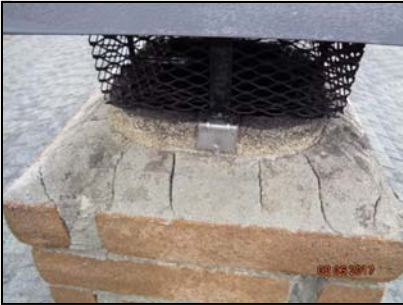
2.2 Item 2(Picture)

2.2 (2) Some slight cracking was noted around the chimney crown.

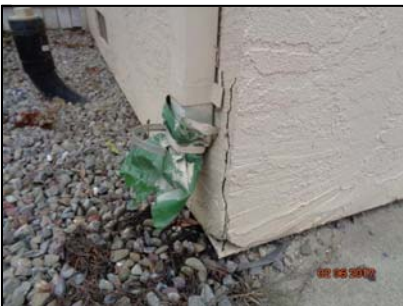
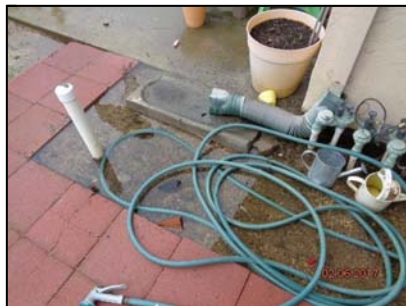
2.4 Item 2(Picture)

2.4 (2) Recommend the gutter downspout at the back left and right side of the front house be directed away from the foundation to help promote proper drainage.

- (1) The downspout located next to the living room is disconnected.
- (2) Recommend the gutter downspout at the back left and right side of the front house be directed away from the foundation to help promote proper drainage.

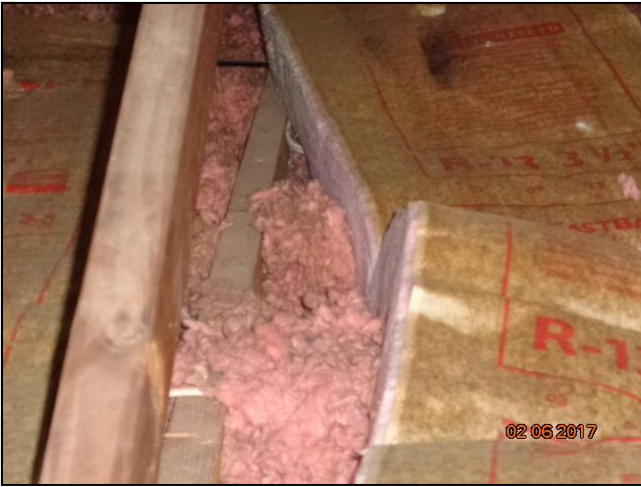
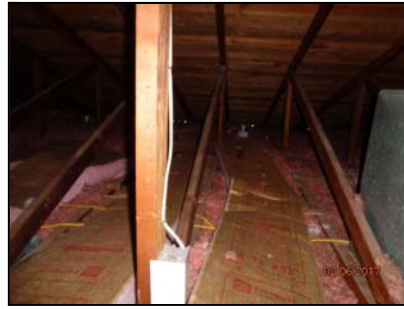
2.6 Item 1(Picture)

2.6 (1) The insulation depth is less than recommended in some areas of the attic in the main building.

2.6 (2) No insulation was found above the attic hatch of the main building.

- (1) The insulation depth is less than recommended in some areas of the attic in the main building.
- (2) No insulation was found above the attic hatch of the main building.

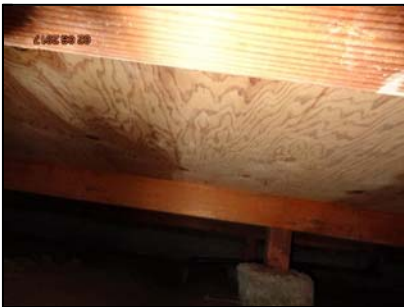
3.2 Item 1(Picture)

3.2 No insulation was found under the floor of the living space.

No insulation was found under the floor of the living space.

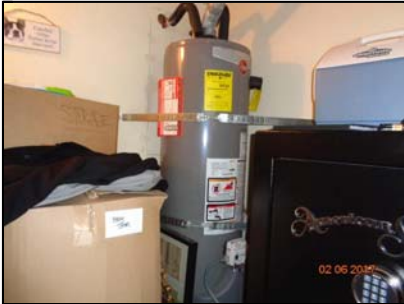
5.0 Item 1(Picture)

5.0 There was limited access to the water heater at the time of the inspection.

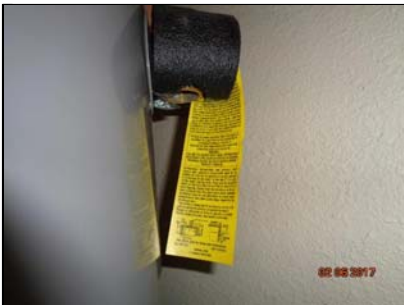
5.1 Item 1(Picture)

5.1 There is no drain line from the TPR valve on the water heater. Recommend a drain line be properly installed.

There is no drain line from the TPR valve on the water heater. Recommend a drain line be properly installed.

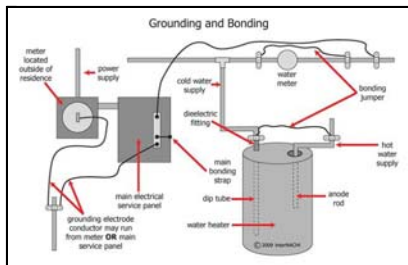
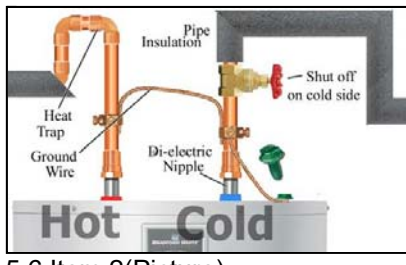
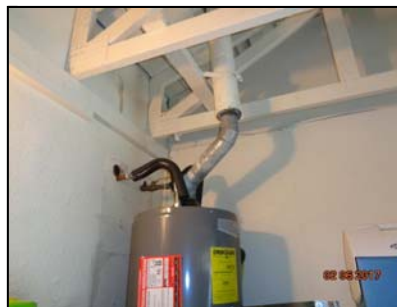
5.6 Item 1(Picture)

5.6 There is no copper bonding connecting the water lines.

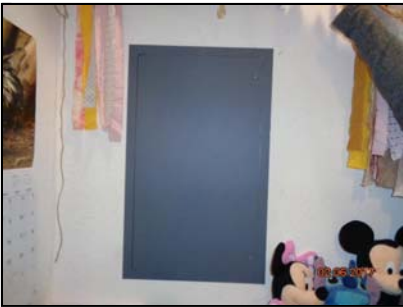
6.2 Item 1(Picture)

6.2 The distribution panel was not able to be opened. Recommend further evaluation by an electrical contractor.

The distribution panel was not able to be opened. Recommend further evaluation by an electrical contractor.

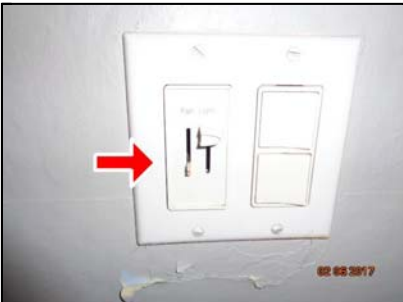
6.5 Item 1(Picture)

6.5 (1) Wall switch in the master bedroom is missing a switch cover.

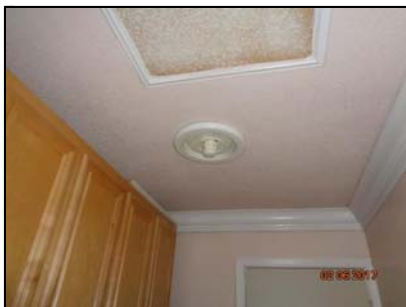
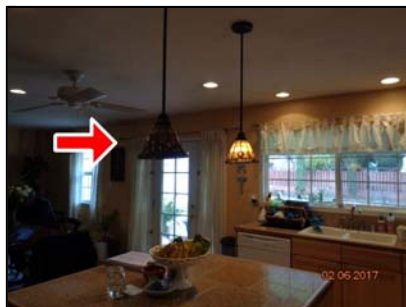
6.5 Item 2(Picture)

6.5 (2) The laundry room light and one light fixture in the kitchen did not respond to the controls.

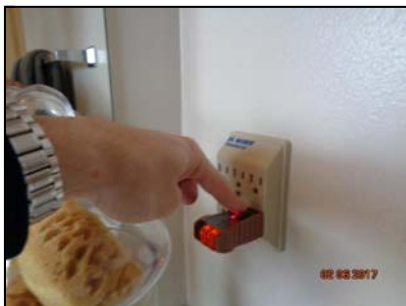
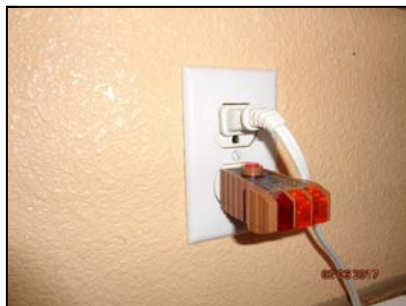
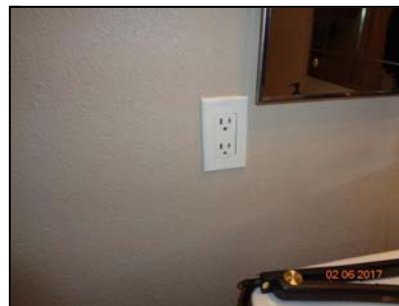
6.6 Item 1(Picture)

6.6 The outlets in the bathrooms of the main and rear buildings are not GFCI (Ground Fault Circuit Interrupter) protected.

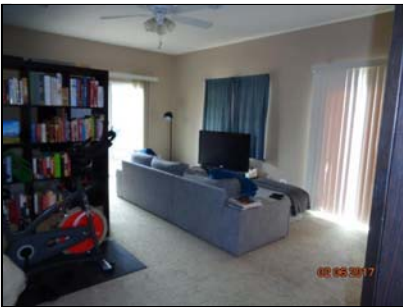
7.0 Item 1(Picture)

7.0 No heating equipment was found in the rear building.

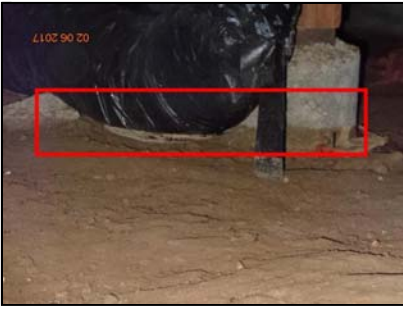
7.2 Item 1(Picture)

7.2 Some of the distribution lines in the crawl space were touching the ground.

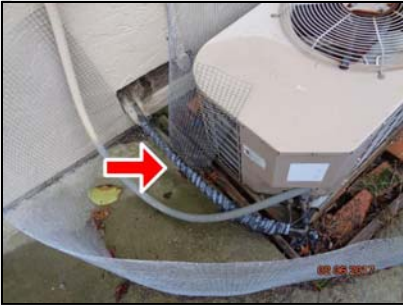
7.4 Item 1(Picture)

7.4 (1) The insulation on the A/C suction line is damaged or missing. Recommend repair to prevent condensation from dripping on the ceiling below.

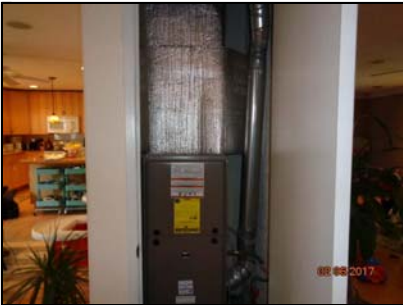
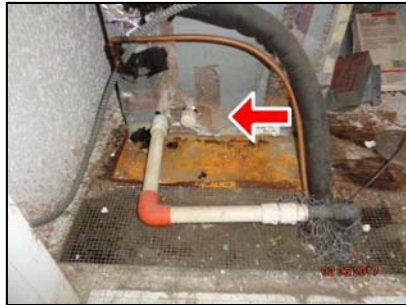
7.4 Item 2(Picture)

7.4 (2) The overflow condensation line is capped off. Rust was evident in the overflow pan under the furnace. I recommend further evaluation by a heating and air conditioning contractor.

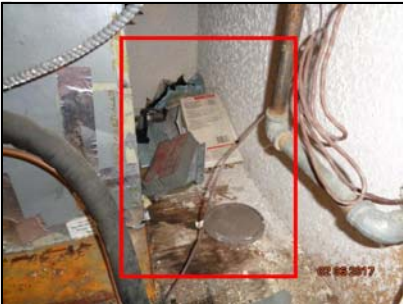
7.4 Item 4(Picture)

7.4 (3) Debris was found next to the furnace in the main building and could become a fire hazard. Recommend removal of debris.

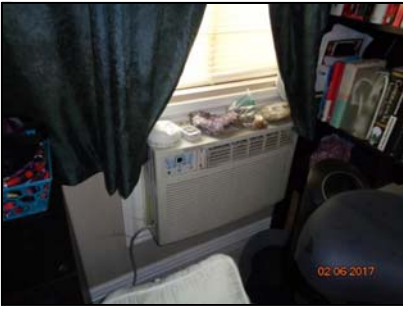
7.4 Item 5(Picture)

7.4 (4) The A/C wall unit in the rear building did not respond to controls.

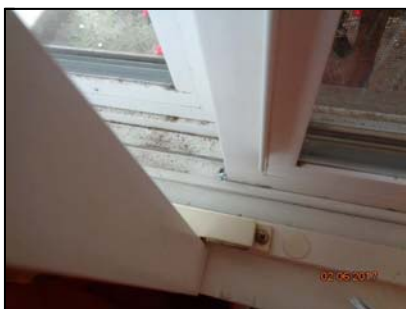
8.4 Item 1(Picture)

8.4 The window(s) located in the front bedroom did not operate properly. A screw was installed to prevent it from opening.

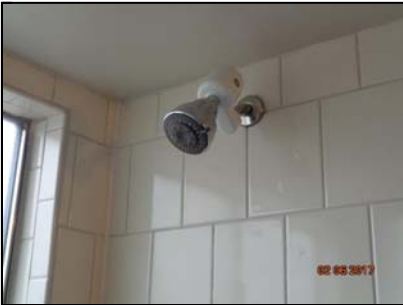
9.0 Item 1(Picture)

9.0 The hall bathroom shower head did not operate properly.

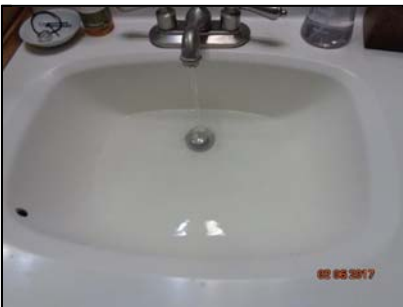
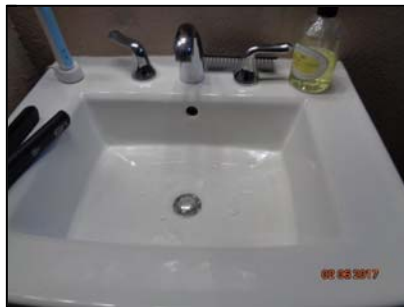
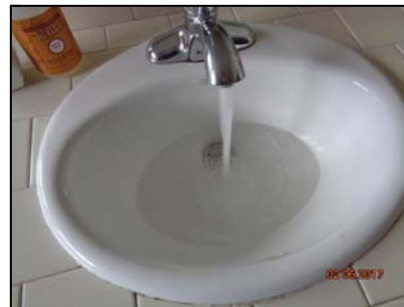
9.2 Item 1(Picture)

9.2 The drains in the main and rear bathrooms drain slowly.

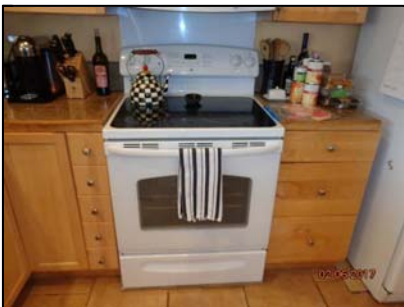
10.1 Item 1(Picture)

10.1 The oven preheated slowly and the displayed temperature did not match the internal oven temperature.

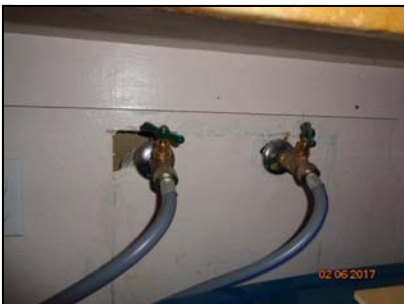
10.6 Item 1(Picture)

10.6 A hole was noted next to the water supply fixture for the washing machine.
